Making Better Impressions

A Troubleshooting Guide

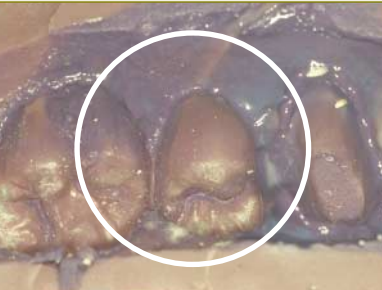
Impression not completely set. Tacky to the touch.

Result Inadequate surface detail on stone reproductions, poor fitting crowns.

Contaminated wash material

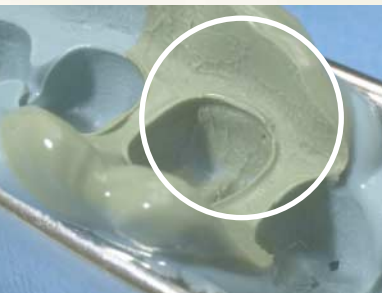
Surface inhibition

Sulfur in latex gloves or rubber dam inhibits the setting reaction of VPS, but does not affect polyether impression material.

Touching prepared teeth or surrounding tissue with latex glove.

Rolling retraction cord with latex gloved fingers.

Exposure to residues from custom temporary materials.

Exposure to air inhibited methacrylates (i.e., composites, adhesives).

Wear nitrile gloves or gloves proven not to inhibit set of VPS impression materials immediately prior to making final impression.

If contamination suspected, scrub affected area with diluted hydrogen peroxide.

Do not use impressions already used to fabricate the temporary restoration.

Fabricate the temporary crown or bridge after final impression has been made.

Remove air inhibited layer on the exposed surface with an alcohol wipe before making final impression.

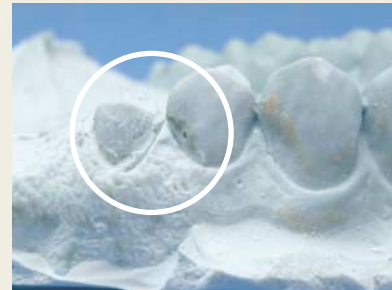
Die stone with impression material residue

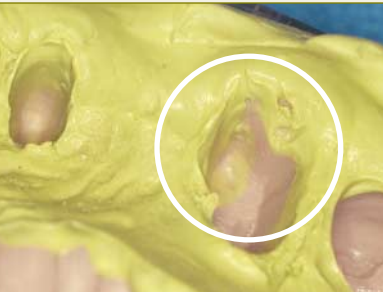
Muted detail reproduction and inadequate margins.

Result Crowns may be too tight or small and extensive occlusal adjustments may be required.

Inadequate retraction

Blood/saliva contamination around prep.

Inadequate retraction of sulcus around prep.

Exceeding the working time of the impression material.

Rinse and dry prep area just prior to making impression.

Good retraction technique with proper moisture control and proper tissue retraction.

Follow manufacturer's working time specifications.

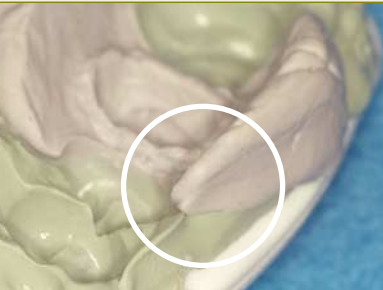
Heavy body and light body materials not blending, or adhering together.

Result Indirect restoration will not seat properly.

Poor bond between heavy body/light body materials

Exceeding the working time of the impression material.

Contamination of pre-set heavy body material in two-step technique.

Follow manufacturer's working time specifications.

Ensure VPS impression material does not come into contact with latex gloves.

Ensure impression material does not come into contact with methacrylate residue from acrylate temporary materials.

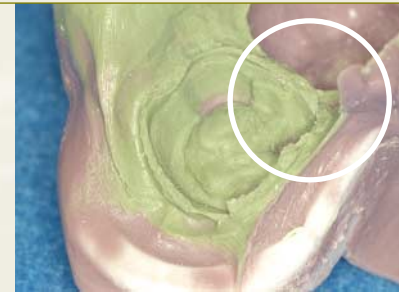
Voids on margin or around prepared teeth.

Result The fit and function of the final restoration may be compromised.

Poor retraction and syringing technique

Air incorporated in intraoral syringe or while filling impression tray.

Improper syringe technique.

Poor retraction around prep.

Retraction cord not left in place adequate amount of time so that no blood or saliva are present.

Front load syringe by inserting mix tip directly into intraoral syringe and keep mix tip immersed in heavy body material while filling the tray.

Keep syringe tip immersed in wash material to avoid entrapping air.

Good retraction technique. Consider two-cord retraction to displace tissue and control fluids.

Good retraction technique, leave cord in sulcus until no blood or saliva are present before syringing the light body impression material. Consider two-cord retraction.

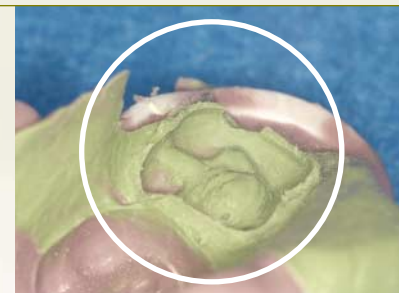
Tearing visible on the margin of the preparation.

Result Short crown margins and/or open margins.

Marginal tear

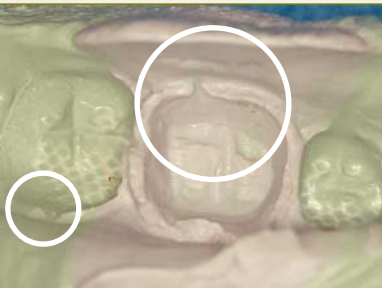
Visual Appearance
Incomplete margin.

Result Short crown margins and/or open margins.

Void caused by syringe technique

Inadequate coverage of marginal area with light body impression material.

Keep syringe tip immersed while syringing.

Gently stir while syringing.

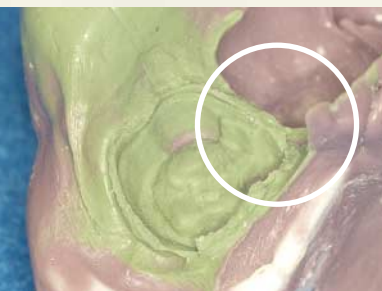
Air bubble on margin

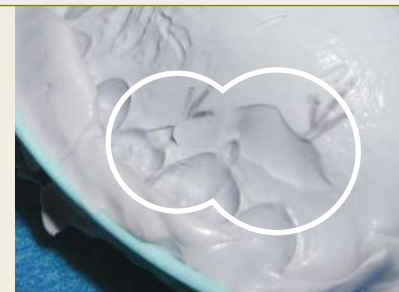
Visual Appearance
V-shaped void, trough-like.

Result Failure to capture
complete and accurate dentition.

Improper tray seating.

Improper syringe technique.

Too little material.

Lingual pulls

Seat tray slowly.

Follow manufacturer's working time.

Use proper syringe technique.

Use more material.

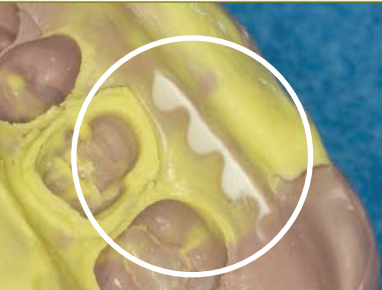
Burn-through of light body impression material.
Impression tray exposed.

Result Crowns are too tight, too small, or rock when seated. Tight fitting crowns.

Contact with impression tray

Prepared teeth contacting the sides or bottom of impression tray.

Tooth contact with the pre-set tray material when using the two-step technique.

Tray seated too quickly or forcefully.

Tray movement or rocking during the impression.

Weaker plastic trays can allow deflection of the tray which may rebound upon removal.

Avoid contact of teeth with any surface of the tray.

Test various tray sizes to ensure proper size.

Relieve the heavy body impression material to ensure a 2–3mm space.

Slowly position tray into patient's mouth.

Use passive pressure to immobilize the tray for the recommended set time.

Use a stiffer, more rigid stock tray.

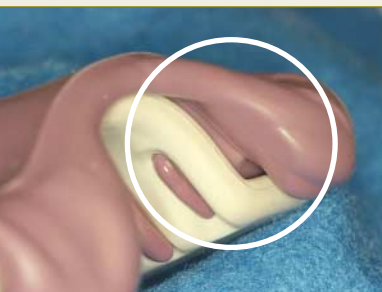
Impression pulling away from the sides/bottom of tray.

Result Crown(s) may not seat fully, or require excessive occlusal adjustment.

Separation of material from tray

No tray adhesive used.

Incompatible tray adhesive used.

Inadequate drying time for tray adhesive.

Use appropriate tray adhesive.

Follow manufacturer's instructions for application and drying time.

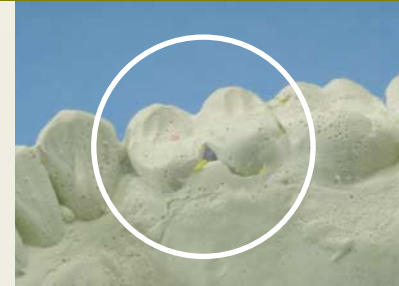
Small voids due to hydrogen gas evolution from the polymerization of VPS materials.

Stone model with hydrogen evolution voids

Use a surfactant for a VPS impression.

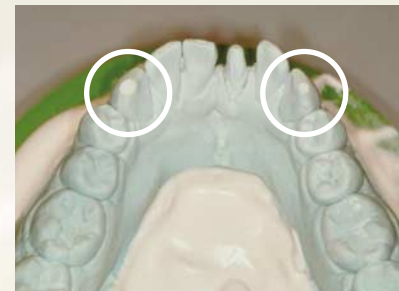
Tooth contact with impression tray or gauze of double bite tray causes water to leach out of the tray, dehydrating the stone.

Stone model with powdery cusp tips

Avoid tooth contact with any surface of the impression tray.
